Updated - Technical Service Bulletin

SUBJECT: REMEDIAL PROCEDURE TO ADDRESS POSSIBLE OXYGEN LEAKS FROM CONTROL VALVES

BULLETIN NO.: TSB 2018-01 (Revised)

AFFECTED MODEL(S): **BR-22 PLUS** EXOTHERMIC CUTTING TORCH

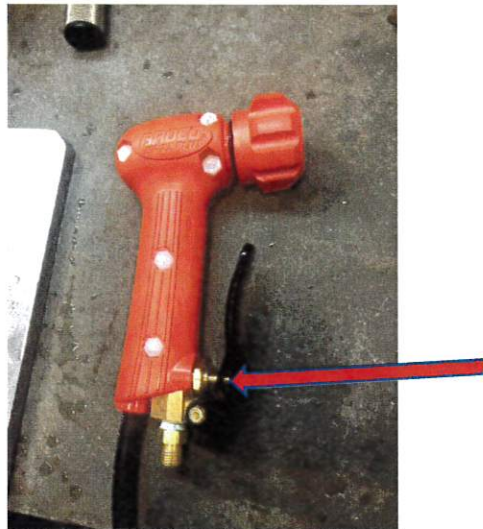
- The picture below shows what a BR-22 PLUS torch looks like and the location of the valve stem leak. If this is not what your torch looks like, do not continue!

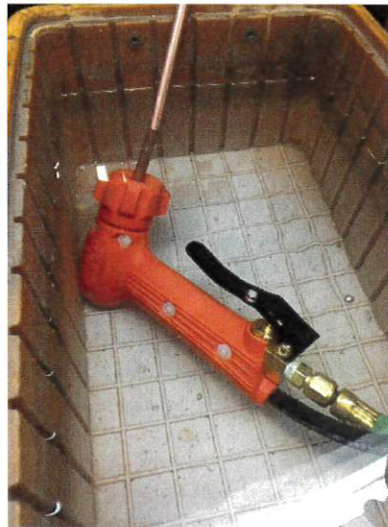
- Outfit the BR-22 PLUS torch as shown with an 18" cutting rod inserted and the collet tightened.

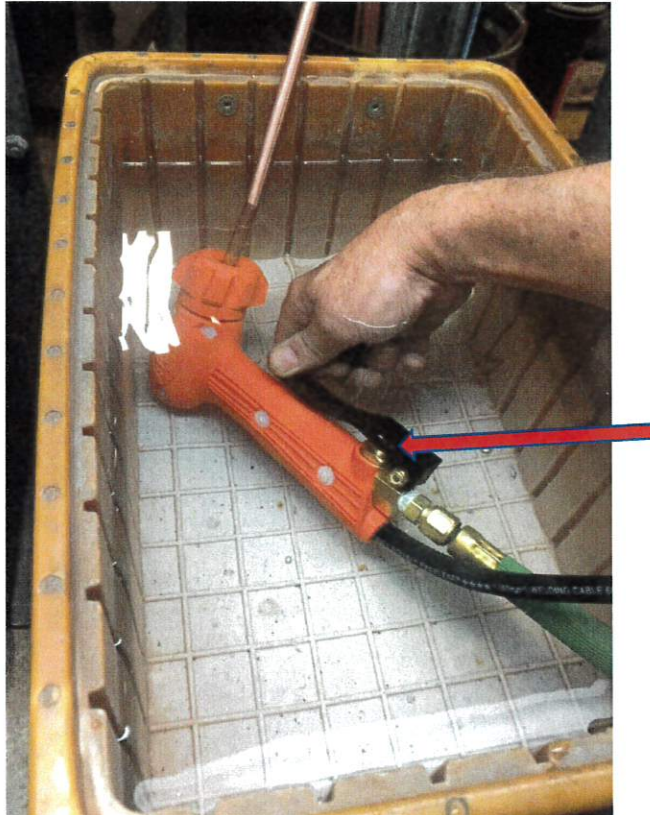
- Set oxygen pressure to 180psi (double that of normal operating pressure) and submerge the entire BR22 PLUS torch under water in a suitable container of your choice with the end of the cutting rod raised above the water to exhaust the oxygen gas. Be sure that the valve section is submerged at least 2" below the water surface for clear detection of any possible oxygen leaks.
- Keep the BR22 PLUS submerged for about 30 seconds before carrying out the next steps. You will likely see some bubbles here from air pockets inside the torch body.
- With the end of the rod raised above water, depress the valve lever with a 2 second count and while doing so, inspect the valve stem area (shown in the picture with a red arrow) for any steady stream of bubbles. Repeat this step 5-10 times.

- If the stream of bubbles is present, please remove the BR22 PLUS torch from service and contact Broco-Rankin. If there are no visible leaks, please resume use of the product as intended.
